HAZARD ALERT

REMOTE CONTROL SCOOPTRAM INCIDENT

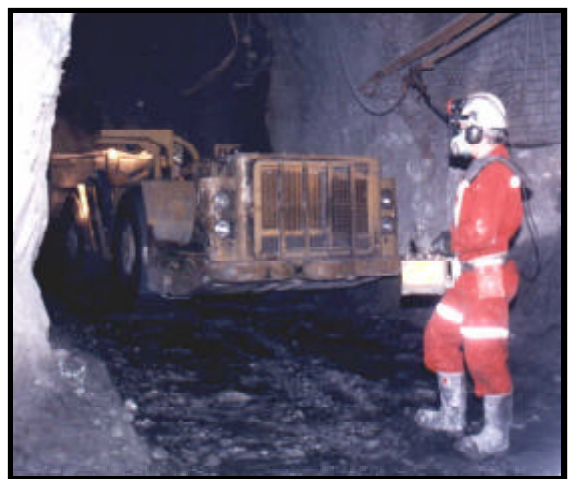
A scooptram operator with eighteen years experience was operating a remote control eight yard Toro scooptram in a 27 metre long draw point access at the Ruttan Mine on March 10, 2002.

Twenty-two buckets of muck had been successfully removed from the draw point. When the twenty-third bucket was recovered, the operator reversed the machine as was the normal procedure. As the unit approached the operator, who was positioned 7.5 metres behind the unit in the travelway, he placed the throttle handle in the neutral position. The vehicle did not respond. He then hit the emergency brake, but the scooptram continued to advance toward him at full throttle. At this point the operator panicked and did not hit the kill switch; he turned to the drift wall and squeezed himself into position, hoping for the best. The unit brushed his lamp battery as it went by, and came to a stop when it impacted the wall at the turn to the main drift.

The operator was not utilizing the drift wall cut out located 20 metres back from the brow. Company policy states that an operator must maintain 15 metres between himself and the unit at all times.

Company officials, through discussions with the Mines Inspector, determined the underlying causes in consultations with the manufacturer. Necessary modifications were made to the remote control unit and the equipment was released back to the operations.

All concerned must recognize that the safety features on mechanical equipment may fail. It is important to make sure the operator is provided with and uses a drift wall cut out.
